# Manhole Inspection Summary

Manhole # S29Q1\_008MH

Insp Date: **2/21/08 10:57 AM**

**Location** Address: **2812 Denham Cir. N (behind The Building)**

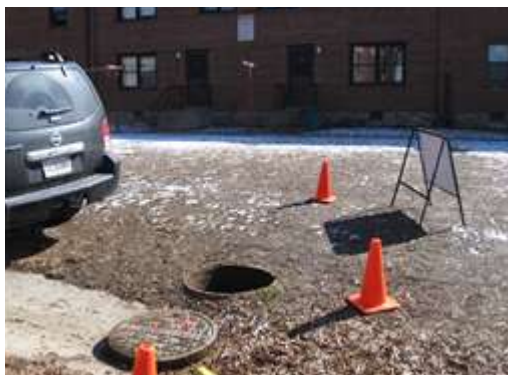
Location View

Building 2812

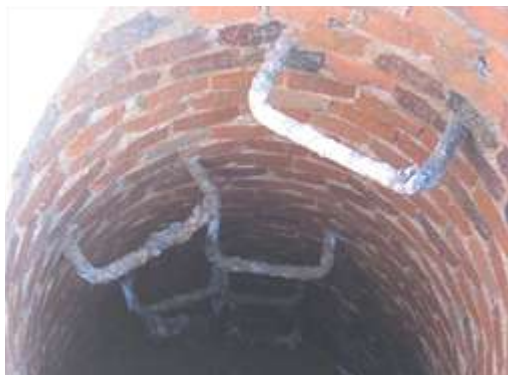
Steps

**Steps** Count: **7** Missing: **0** ☒ **Corroded**

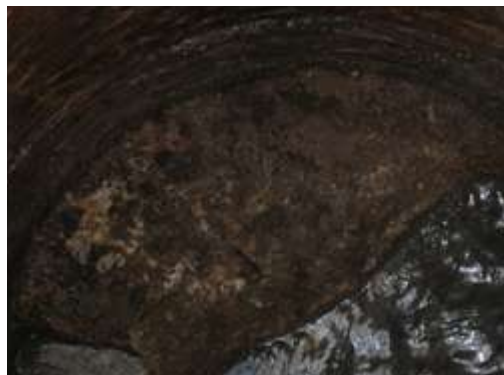
Defect 1

Condition: ☐ Sound ☐ Cracked ☐ Root Intrusion ☐ Deteriorated ☐ Leaks ☒ **Debris**

Bench

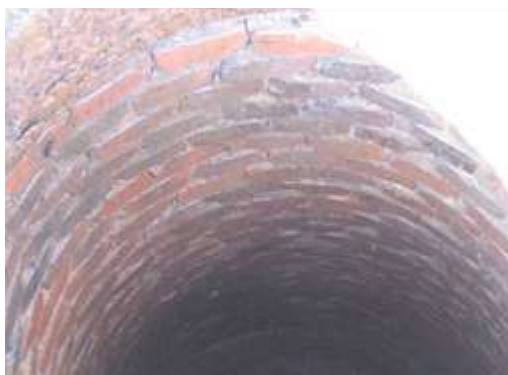
Defect 2

Infiltration: ☐ None ☐ Joint ☐ Cracks ☐ Mortar ☐ Roots ☒ **Wall**

wall

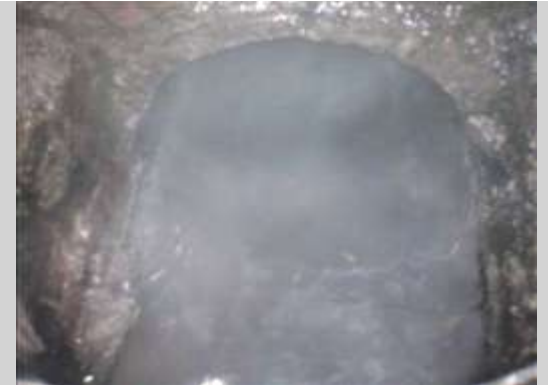
12 O'Clock Outflow

12 in. Circular Gravity Sewer  
Pipe Out @ 12 O'Clock

Pipe Height: **13.2** (in.) Rod and Bar (Angled)  
Pipe Material: **Clay** ☐ Pipe Lined  
Invert Depth: **12.54** (ft.) Flow Characteristics: **Fast**  
Deposits: ☒ None ☐ Mud ☐ Sludge ☐ Debris ☐ Grease  
Silt Depth: (in.) Deposits Extent:  
Infiltration: **None** Pipe Seal Cond: **Sound**

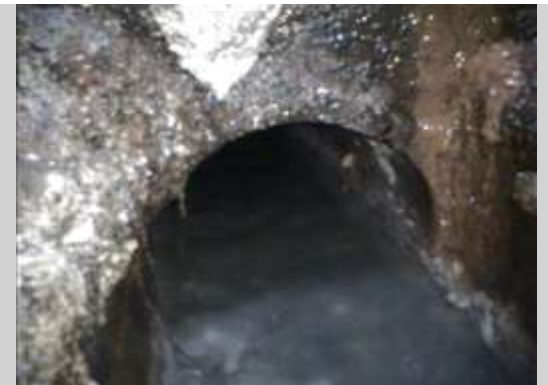
4 O'Clock Inflow

12 in. Circular Gravity Sewer  
Pipe In @ 4 O'Clock

Pipe Height: **12** (in.) Rod and Bar (Angled)  
Pipe Material: **Clay** ☐ Pipe Lined  
Invert Depth: **12.32** (ft.) Flow Characteristics: **Fast**  
Deposits: ☒ None ☐ Mud ☐ Sludge ☐ Debris ☐ Grease  
Silt Depth: (in.) Deposits Extent:  
Infiltration: **None** Pipe Seal Cond: **Sound**
